# Lake Warren Watershed Management Plan Development and Implementation Project, Phase 1

**A Final Report to**

**The New Hampshire Department of Environmental Services**

**Submitted by**  
**Lisa J. Murphy, Senior Planner**  
**Southwest Region Planning Commission**  
**37 Ashuelot Street**  
**Keene, NH 03431**

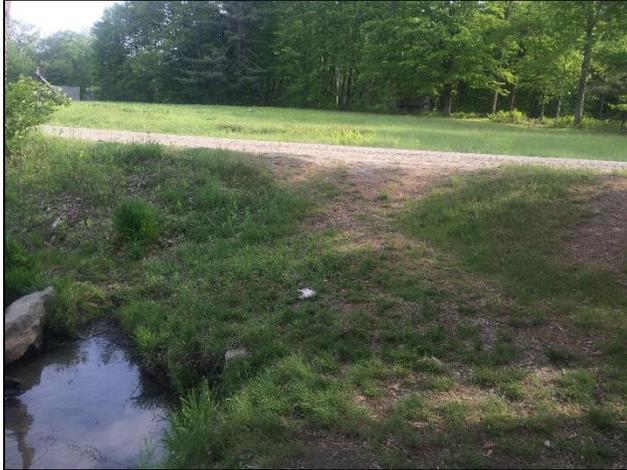
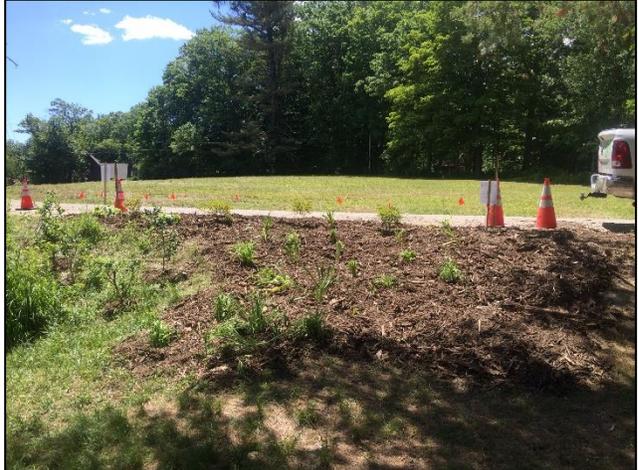
One of the demonstration projects involved the restoration of a bank along Pine Cliff Road. The location was selected due to the compaction of the area and the stormwater runoff from the road. On June 18, 2016, a group of volunteers prepared the soil and planted native, non-invasive plants to provide stabilization and to deter the public from walking in that area. A path for public access was left for the public to use to enter the lake or to fish from the shore.

*Before (left) and after (right) condition of vegetated buffer along Pine Cliff Road.*

Pine Cliff Road Buffer Plantings- On June 18, 2016, nine volunteers helped install a buffer planting along Pine Cliff Road. Previously, there was almost no vegetated buffer along a 26-ft stretch of this road, with patches of dirt and grass. Signs of erosion from large volumes of stormwater were visible along the road fill slope. The unvegetated area was planted with over 40 hardy plants to stabilize the slope and encourage infiltration of road runoff. Erosion control mulch was spread between plantings and along a footpath to the lake to help stabilize the bare soil and protect the plantings.

To provide an estimate for the pollutant load reduction for this site, the Water Erosion Prediction Project (WEPP) model was used. The soil in the area of Pine Cliff Road is fine sandy loam, so the sand soil correction factor was used. While it is recognized that all models have limitations, the WEPP model is appropriate for estimating erosion and pollutant load reductions for road BMPs.

Using this model, it is estimated that the Pine Cliff Road BMP controlled the following pollutants: sediment reduced by 0.1 tons/year, Total Phosphorus (*TP*) reduced by 0.1 pounds/year, and Total Nitrogen (*TN*) reduced by 0.2 pound/year.

Another method that can be used for this type of project is the EPA Region 5 Model. Using this method, the results were similar to the WEPP method: Total Suspended Solids (*TSS*) and Sediment reduced by 58 lbs/year and 0.1 tons/year, respectively; Total Phosphorus (*TP*) reduced by 0.1 pounds/year; Total Nitrogen (*TN*) reduced by 0.4 pound/year.

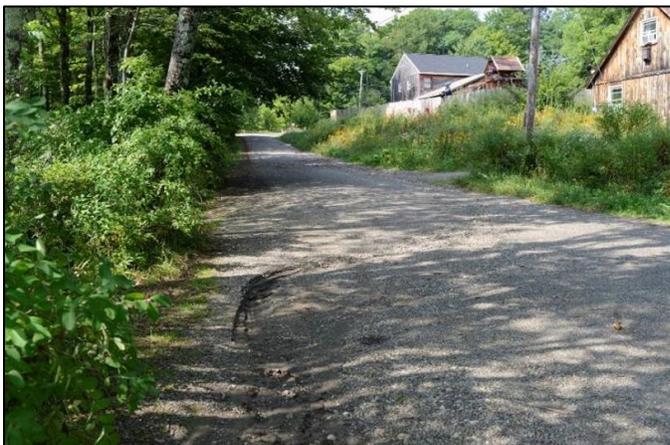
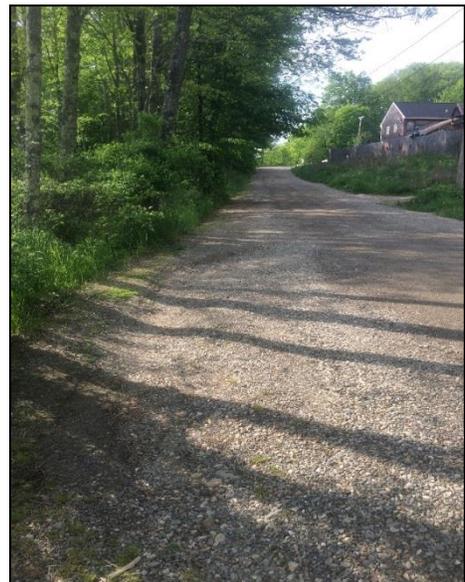
The picture on the left shows the access road with gullies that have eroded during heavy weather events. The picture on the right shows the same location after the road was regraded. A ditch to the right of the access road will be redug in the spring of 2017 to better manage the stormwater runoff and to filter it prior to entering the lake.

Boat Landing Road Regrading- This site had been previously identified in a 2013 Watershed Survey as a potential Best Management Practice (BMP) site due to visible surface erosion and direct flow to the lake. A site visit took place on August 25, 2015 after a heavy rain event and evidence of severe erosion was identified along the access road and along both sides of the boat ramp. On November 19, 2015, the road agent re-graded the access road to provide better road drainage of runoff into adjacent ditches (instead of down the road toward the lake).

To provide an estimate for the pollutant load reduction for this site, the Water Erosion Prediction Project model was again used, including the sand soil correction factor.

Using this model, it is estimated that the Boat Landing Road BMP controlled the following pollutants: Sediment reduced by 0.2 tons/year; Total Phosphorus (*TP*) reduced by 0.1 pounds/year; and Total Nitrogen (*TN*) reduced by 0.3 pound/year.
