# Road Safety Audit

## Intersection of NH 12 and 119, Fitzwilliam, NH

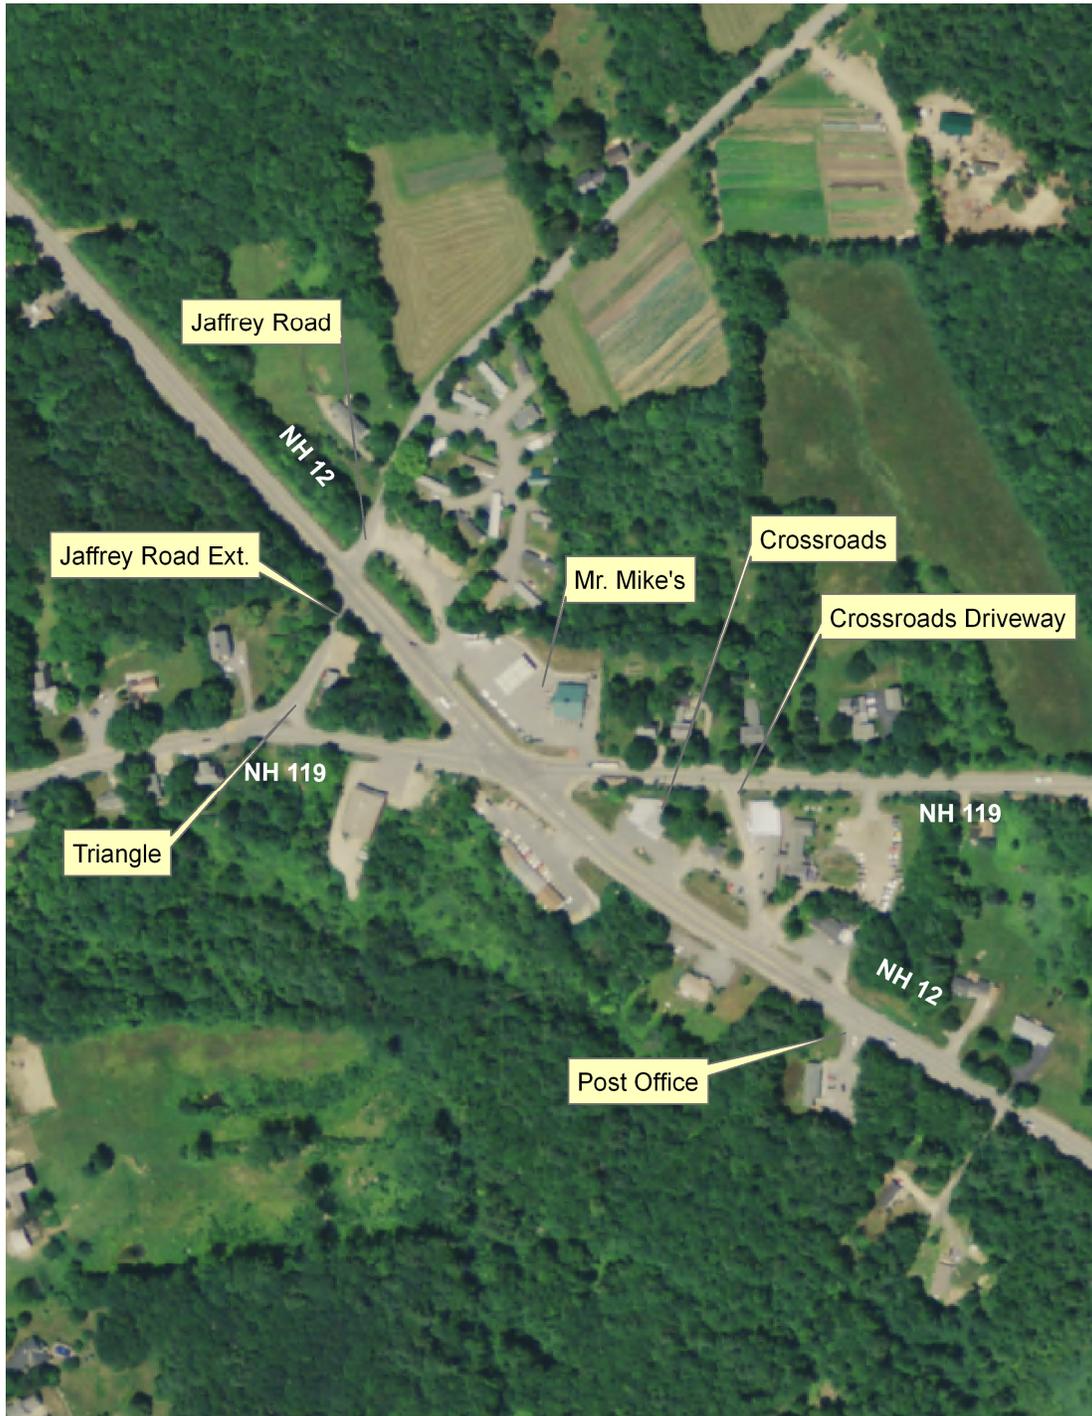
### 1.3 Project limits

This RSA focuses on the safety of the intersection of NH 12 and NH 119 as well as the approaches to the intersection. The approaches were reviewed to the extent at which the RSA team surmised that they were impacting the safety of the intersection. Factors such as hill grade, driver speed, signage, sight distance and other factors were variables used to determine the project limits of the approaches to the intersection.
